NATIONAL AERONAUTICS AND SPACE ADMINISTRATION

APOLLO 9 MISSION REPORT

MANNED SPACECRAFT CENTER

MAY 1969

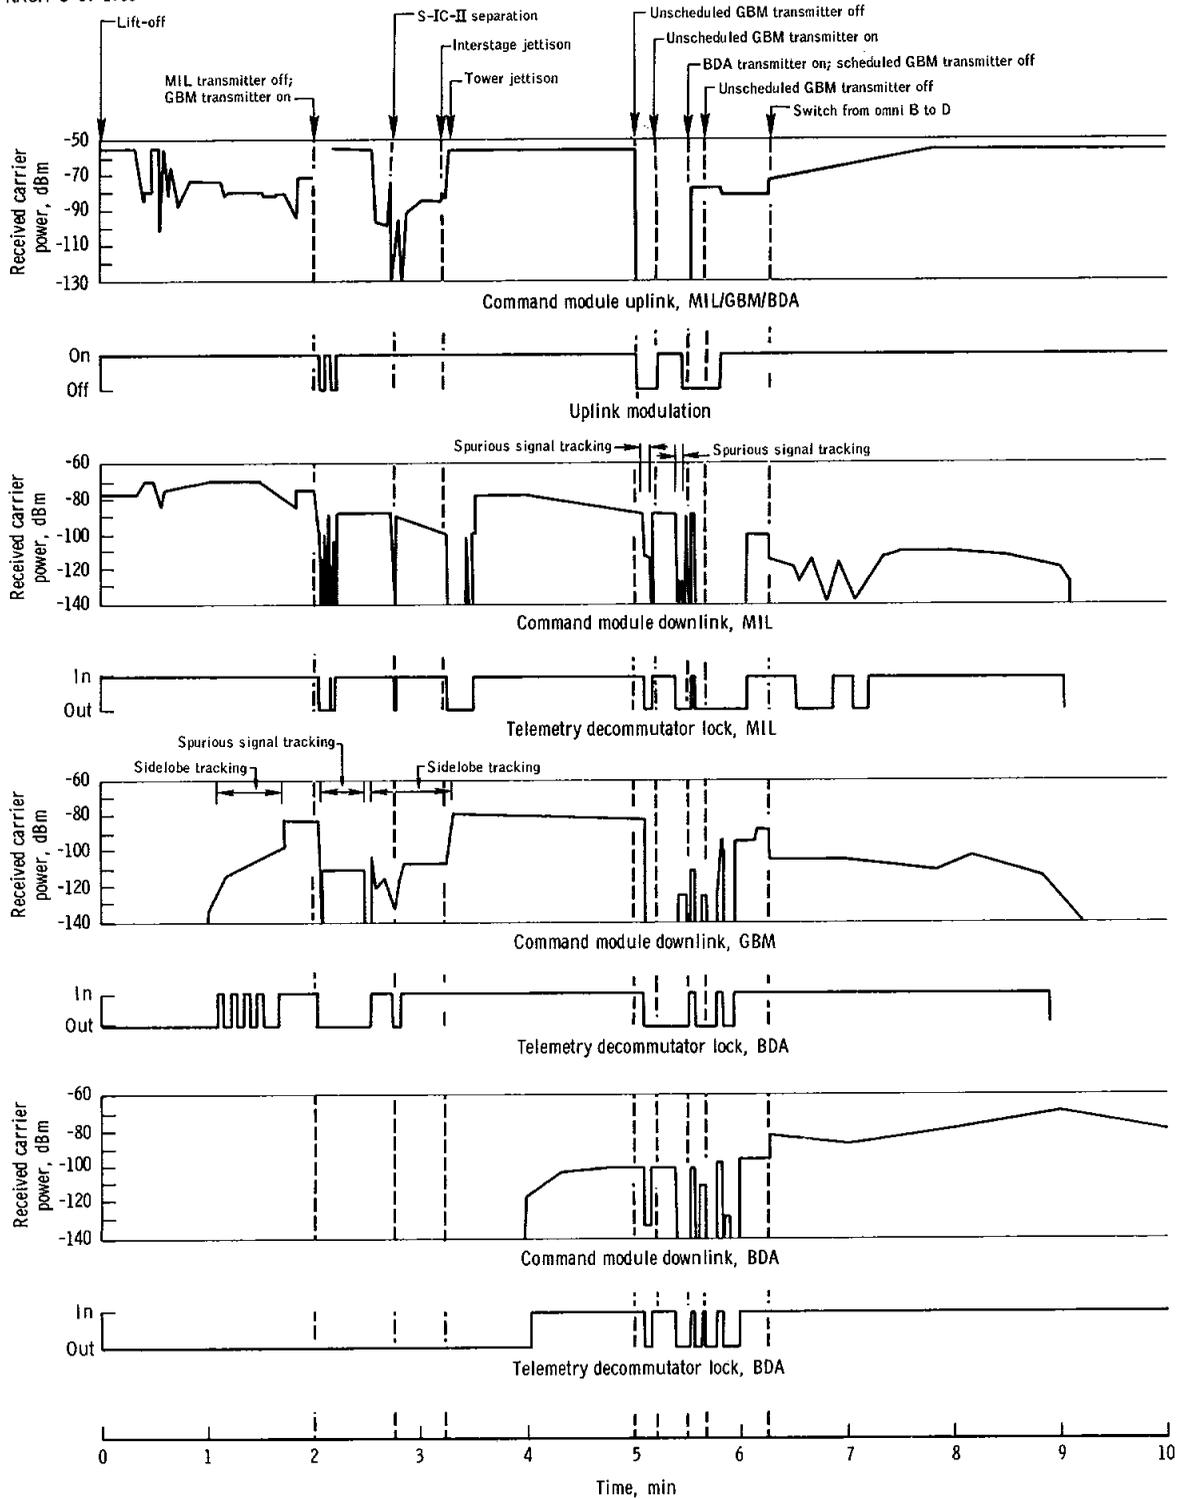
Figure 6-1. - S-band communications during launch.

The first communications problem was a procedural error that occurred during the launch phase. As shown in figure 6-1, procedural errors at the Grand Bahama Island station caused degraded S-band system performance between 0:02:00 and 0:02:32, when the ground receiver locked on to a 51.2-kHz spurious signal in the downlink spectrum, and between 0:02:32 and 0:03:17, when the antenna tracked a sidelobe. A complete loss of S-band communications was encountered between 0:05:01 and 0:06:00 because the operator of the ground transmitter interrupted transmissions 30 seconds early. At 0:05:12, the operator recognized the error and energized the transmitter, but he was unsuccessful in reestablishing two-way phase lock. At 0:05:30 the Bermuda station initiated uplink transmissions as scheduled. The spacecraft transponder immediately locked to the Bermuda signal; however, solid two-way phase lock was not established until 0:06:00. See section 14 for further details.

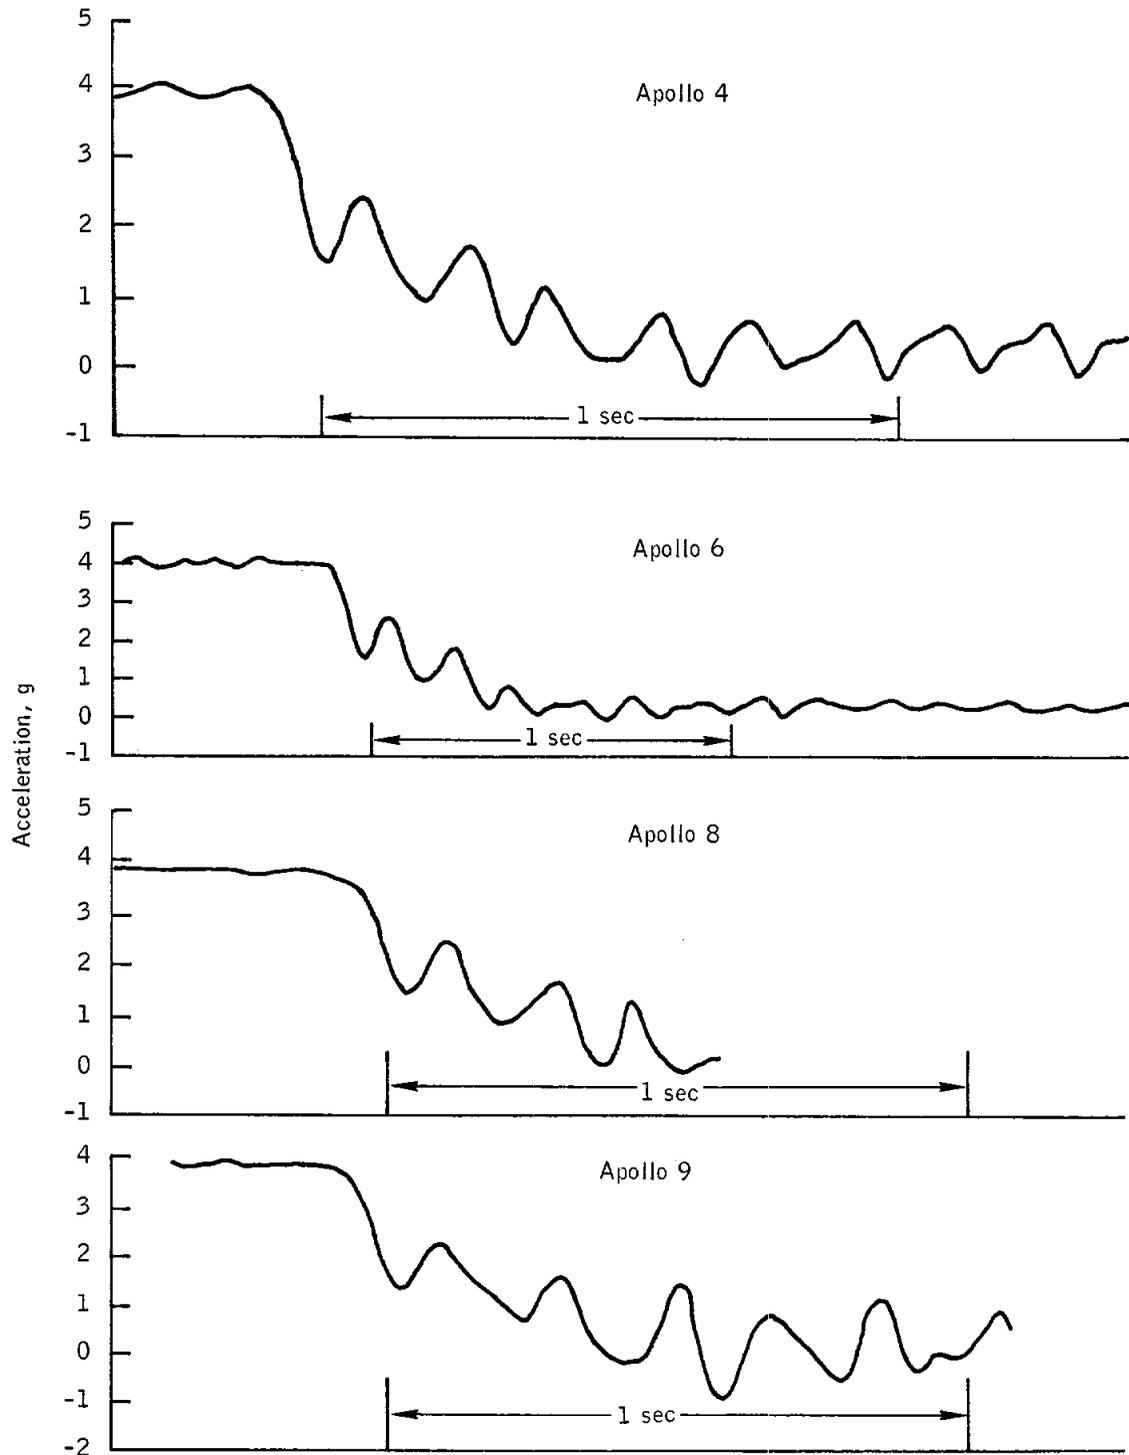
Figure 8.1-1.- Comparison of command module X-axis acceleration at S-IC outboard engine cutoff.

The crew reported experiencing a negative longitudinal acceleration during shutdown and separation of the first stage; the maximum negative acceleration recorded was minus 0.8g at 0:02:43.6. This negative acceleration is greater than any measured in the three previous Saturn V missions (fig. 8.1-1), but it was still less than the design value. This negative acceleration is attributed to a more rapid thrust decay of the first-stage engines from the 30-percent thrust level. The command module accelerations during this period are shown in figure 8.1-2. The measured and predicted maximum tension loads at separation are compared in table 8.1-I.

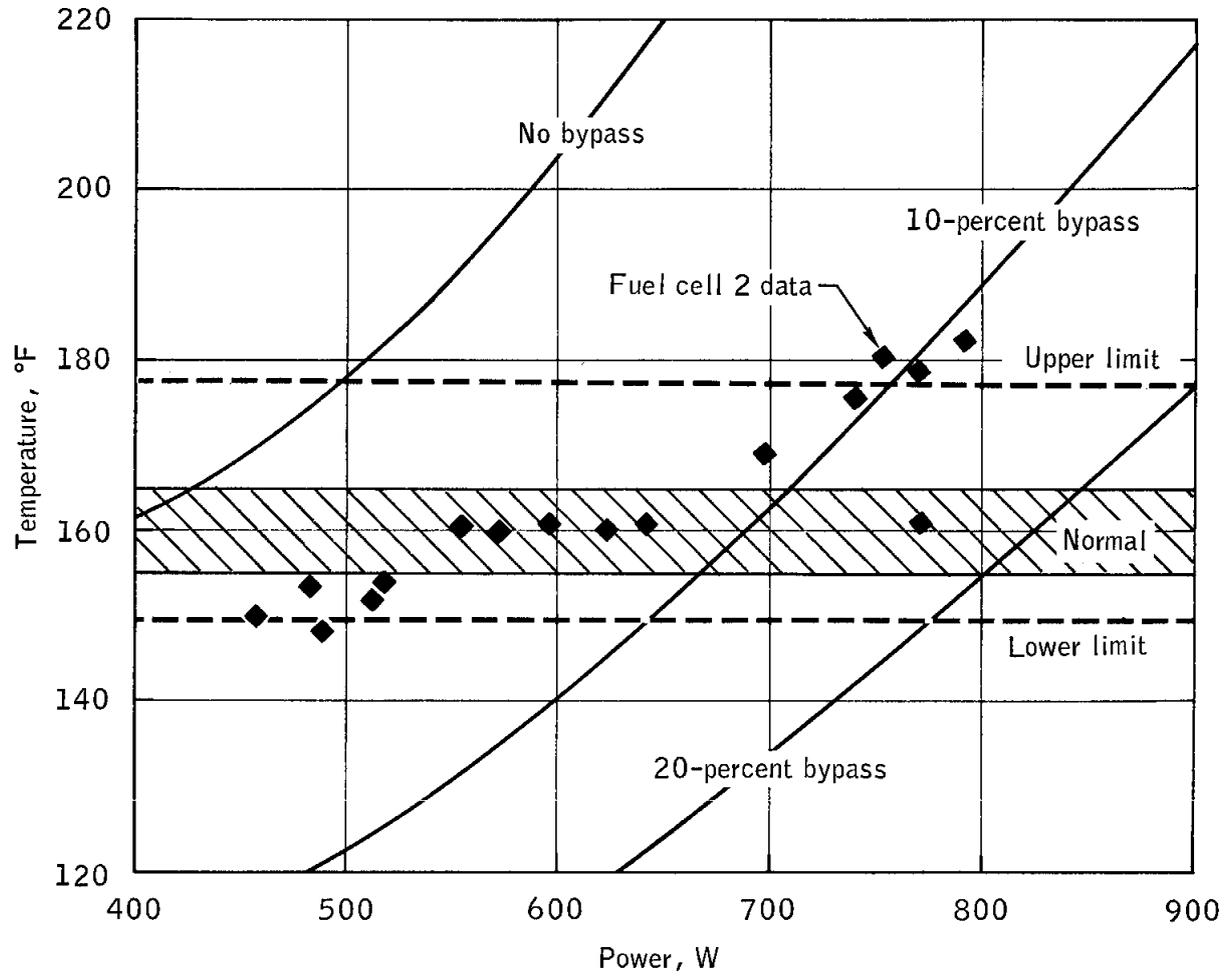
Figure 8.2-1.- Fuel cell 2 condenser exit temperature compared with power output.

The thermal performance under a current load for fuel cells 1 and 3 was within the normal range throughout the flight. The condenser exit temperature for fuel cell 2 was outside the nominal range during power-up and power-down phases between 88 hours to 191 hours, as shown in figure 8.2-1. The minimum condenser exit temperature observed for fuel cell 2 was 148° F at 110 hours with an average current of 15 amperes per fuel cell; the maximum value observed was 184° F at approximately 147 hours with an average current of 27.8 amperes per fuel cell. These and other excursions resulted in low and high caution and warning indications. Fuel cell behavior during this period was very similar to that observed during Apollo 7. The valve travel in the secondary coolant regenerator bypass was restricted between approximately 4 percent and 10 percent bypass during the period from 88 to 191 hours; however, modulation was achieved between these points (fig. 8.2-1). Fuel cell 2 condenser exit temperature returned to normal operating limits after 191 hours under relatively high current conditions. The corresponding bypass valve modulation was normal, between 8 and 19 percent. Section 17 contains a detailed discussion of this anomaly.

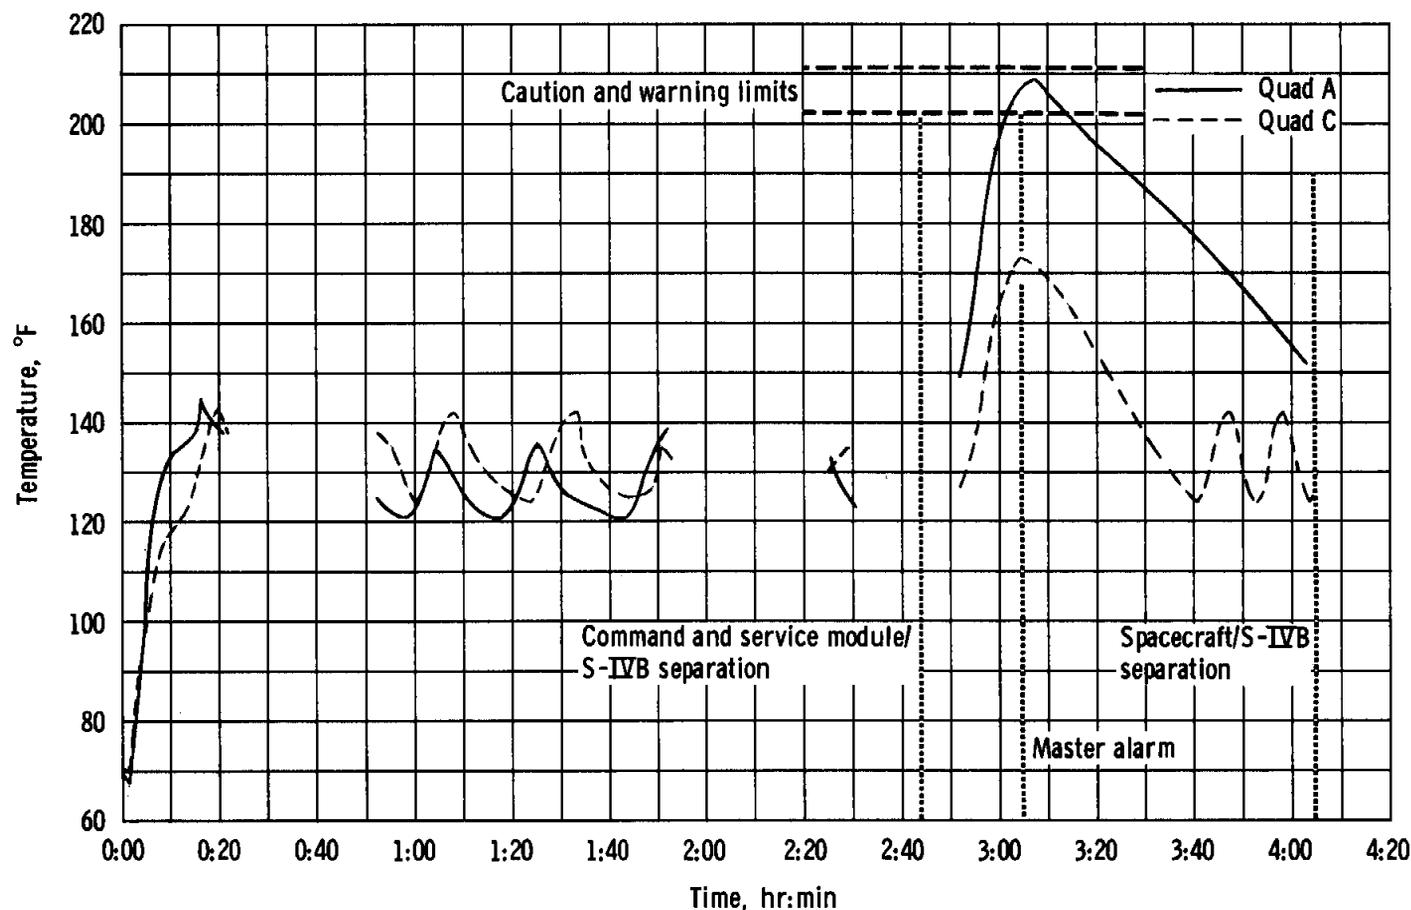
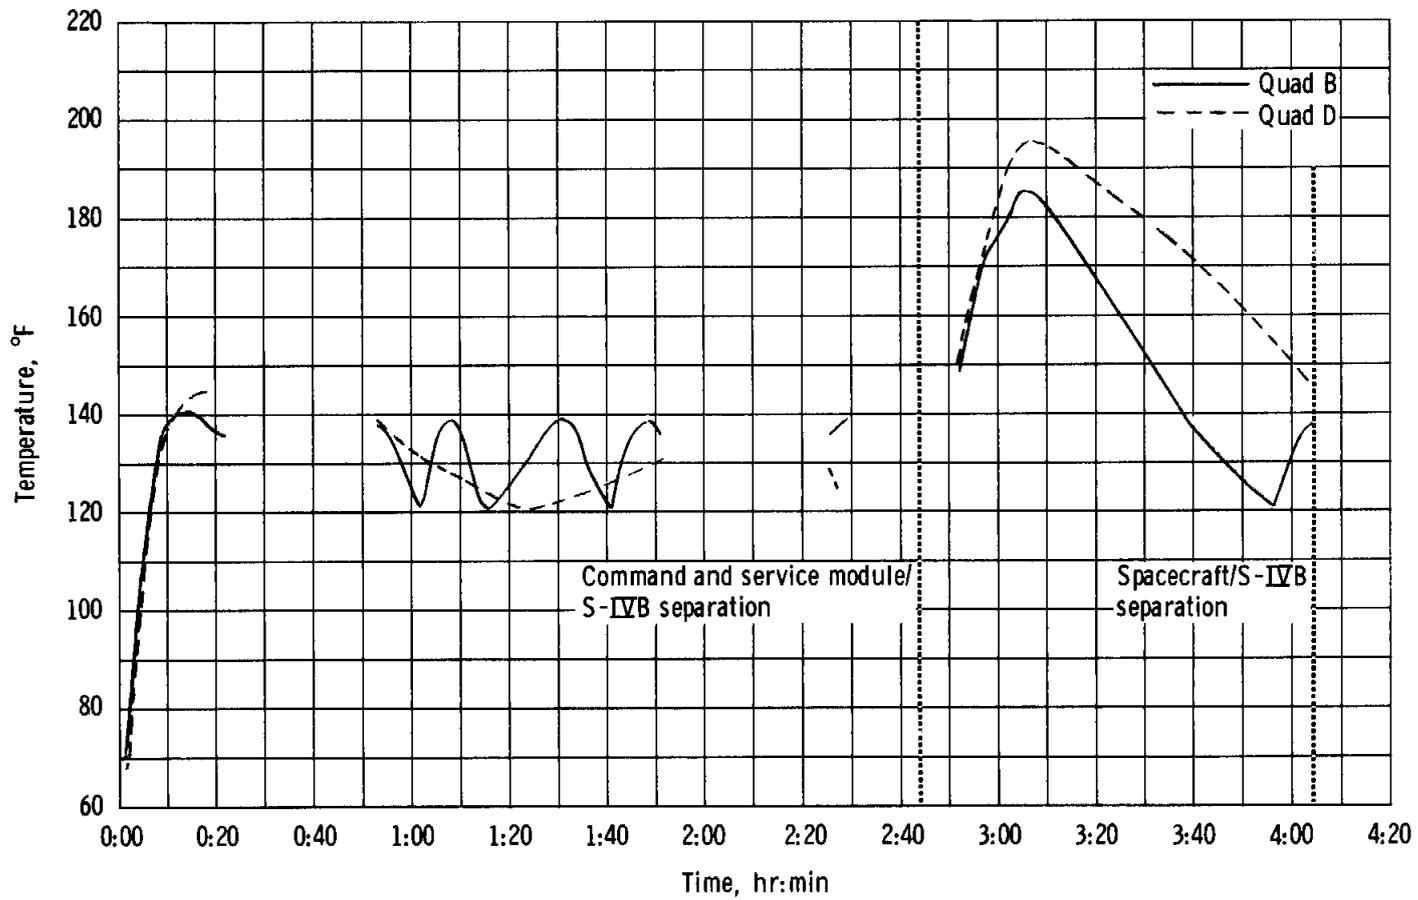
Figure 8.7-1. - Comparison of quad package temperatures from launch through spacecraft separation.

During the time that the quad C isolation valves were closed, high thruster activity was required from quad A. This resulted in a high package temperature on quad A which consequently triggered the caution and warning light. However, as shown in figure 8.7-1, the upper temperature limit of 210° F was not reached. During times of lesser thruster activity, the primary quad heaters maintained the package temperatures between 119° and 141° F.

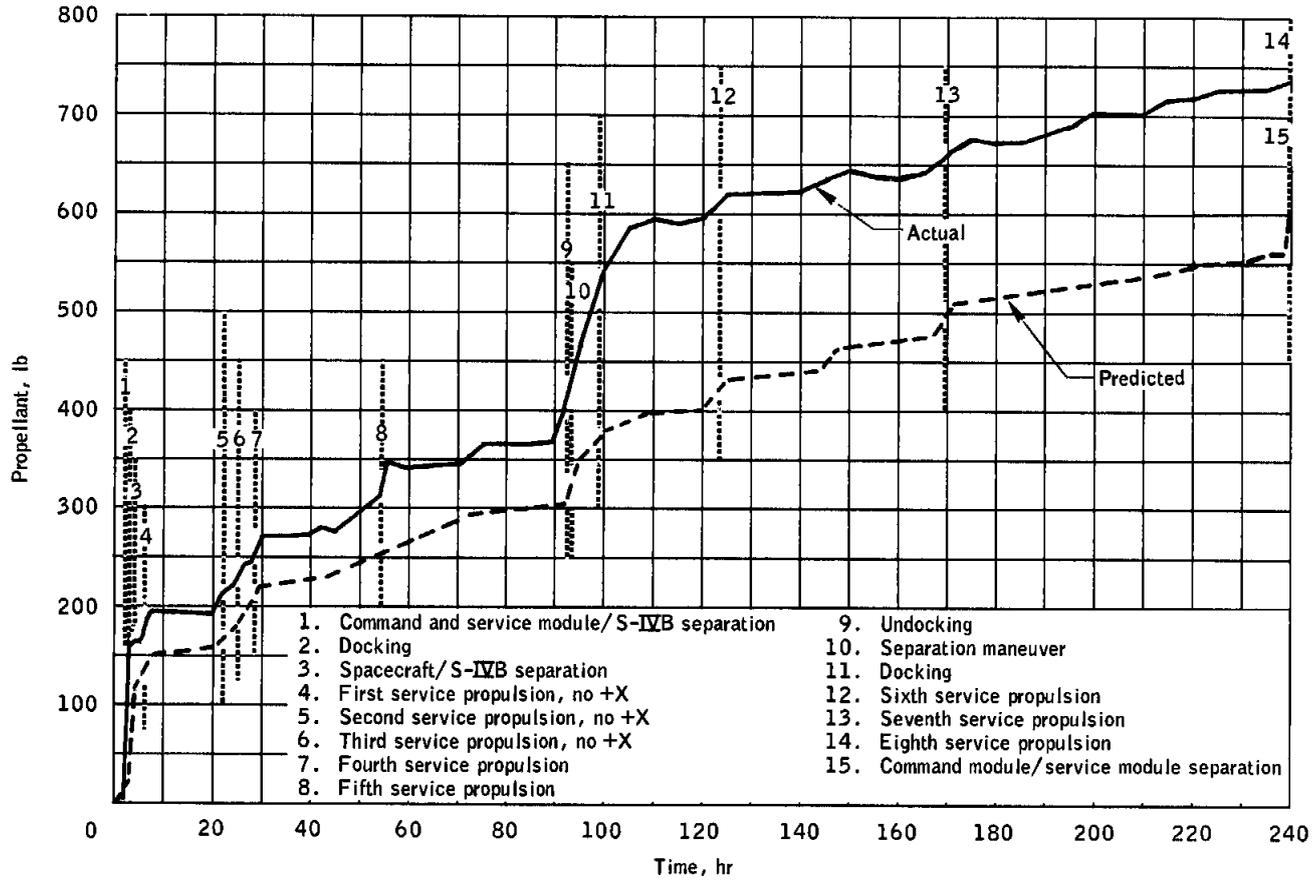
Figure 8.7-2.- Service module reaction control system propellant consumption.

A total of 790 pounds of propellant was used. The actual consumption for all quads is compared with the preflight predicted values, as corrected for flight plan changes, in figure 8.7-2. The total propellant consumption was 192 pounds more than predicted, partly because of the quad C isolation valves being closed but largely because of the exclusive use of the autopilot, rather than the minimum impulse mode, as indicated in section 5.3.2, during the rendezvous. With these exceptions, the actual usage rates approximated the predicted usage. A comparison of ground calculations of propellant remaining with the onboard gage readings is shown in figure 8.7-3. The telemetered gage readings have been corrected for end-point-error and converted from percent remaining to weight of propellant expended.

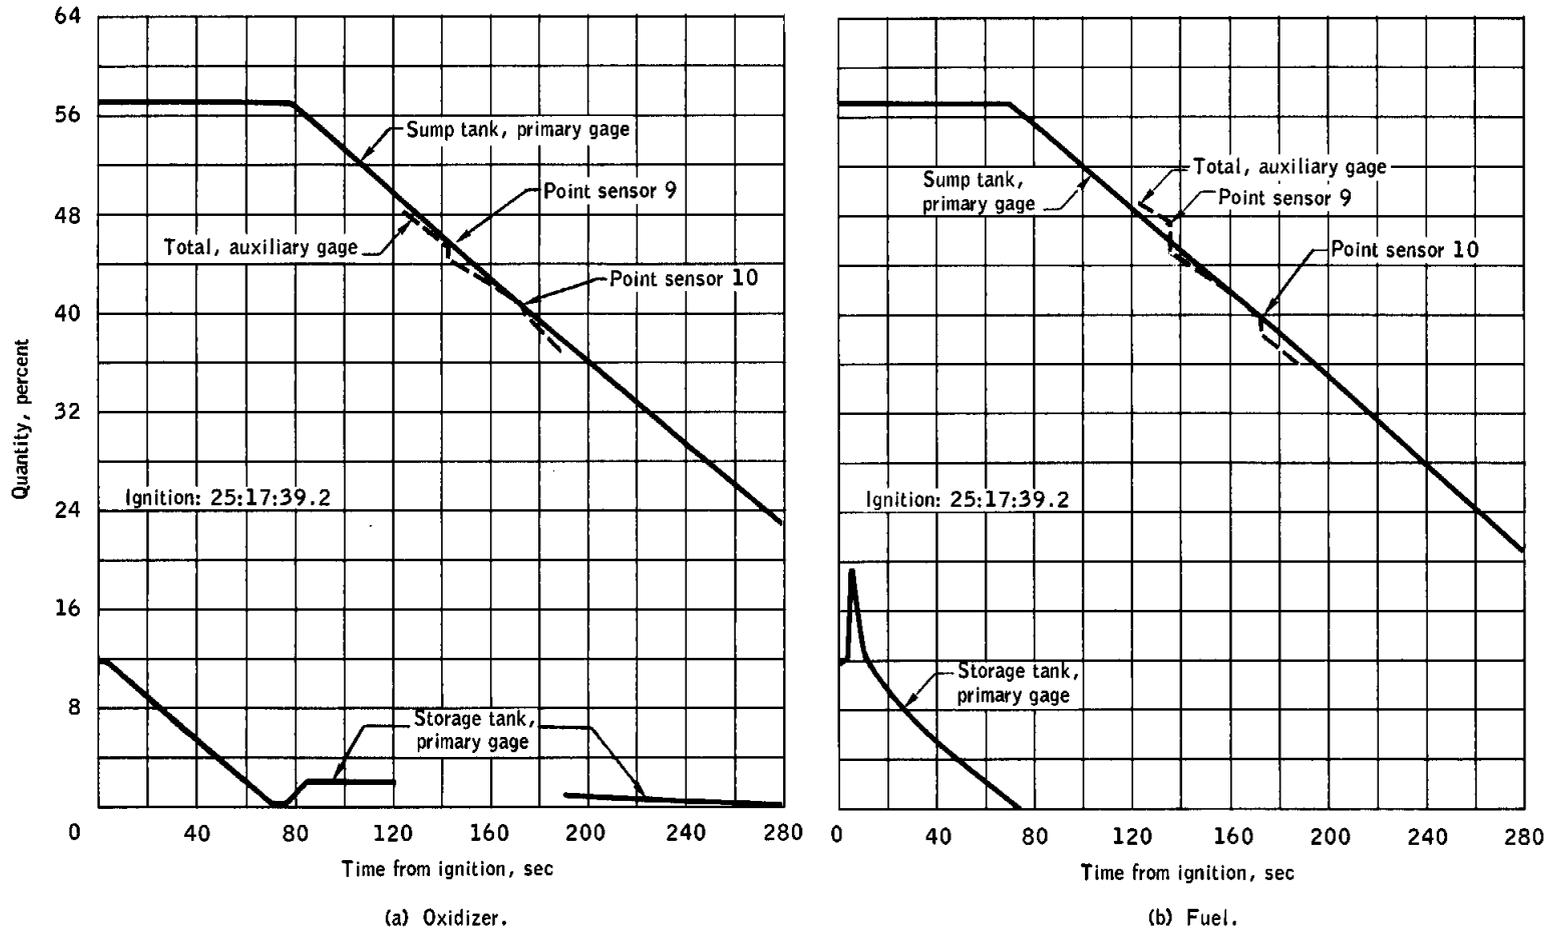
Figure 8.8-1.- Telemetered gaging quantities during third service propulsion firing.

Figure 8.8-1 shows the telemetered gaging system data for oxidizer and fuel during the third firing and figure 8.8-2 shows the indicated unbalance at selected times, as calculated from these data. The unbalance history should reflect the displayed unbalance history within the telemetry accuracy. Also shown in figure 8.8-2 are the times when a caution and warning light was activated. Additional discussion of gaging system discrepancies is contained in section 17.

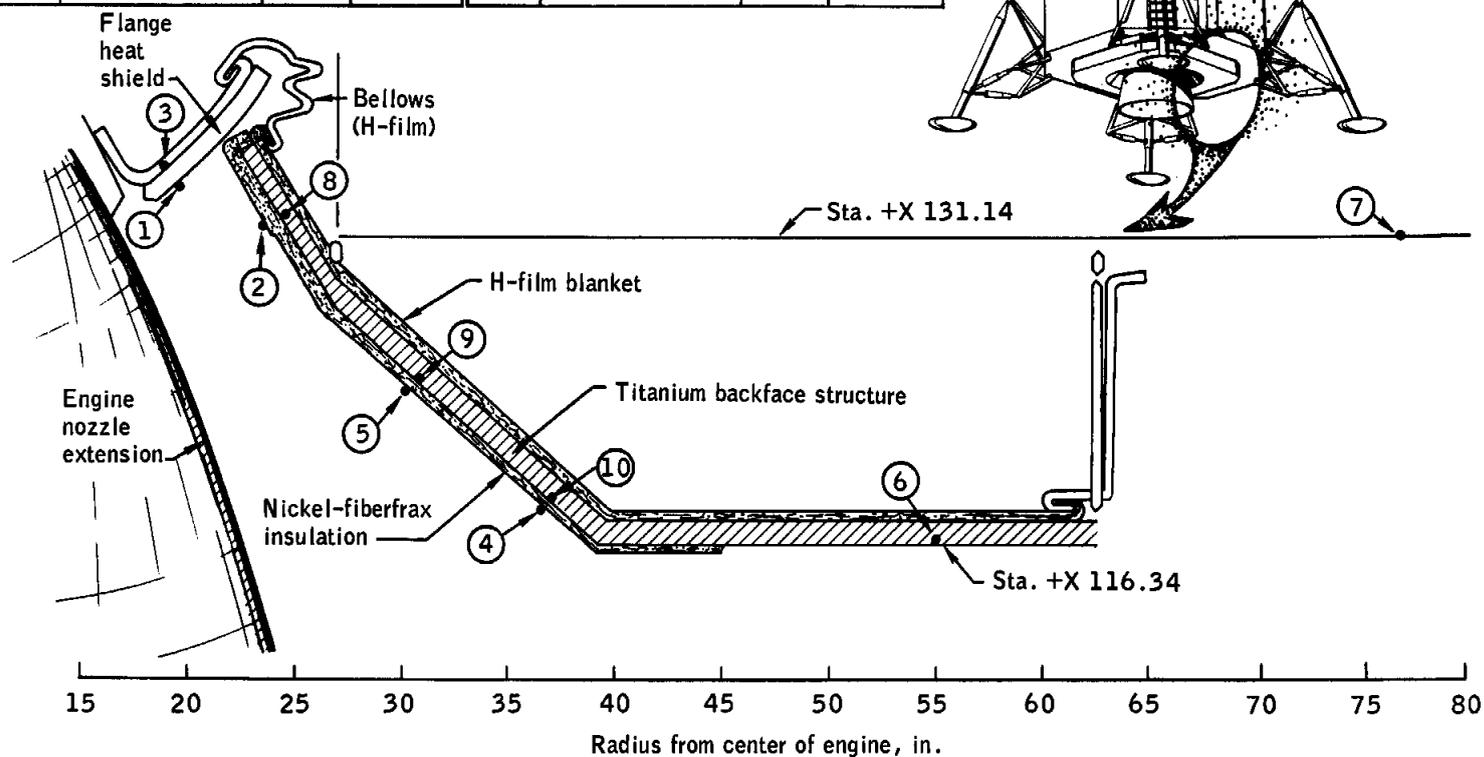
Figure 9.2-2.- Descent stage base heat shield sensor locations and peak temperature.

The temperature response of the descent stage base heat shield was slightly lower than predicted. A comparison of peak temperature, predicted temperature range, and maximum allowable limits is shown in the figure 9.2-2.

No.	Temperature, °F			No.	Temperature, °F		
	Predicted range	Peak	Maximum allowable		Predicted range	Peak	Maximum allowable
1	1790-1930	1650	2100	6	70-550	250	1000
2	1900-2060	1860	2200	7	- -400	65	800
3	800-900	800	1000	8	70-550	275	1000
4	1300-1400	1450	1500	9	70-550	280	1000
5	1600-1700	1650	1800	10	70-550	270	1000

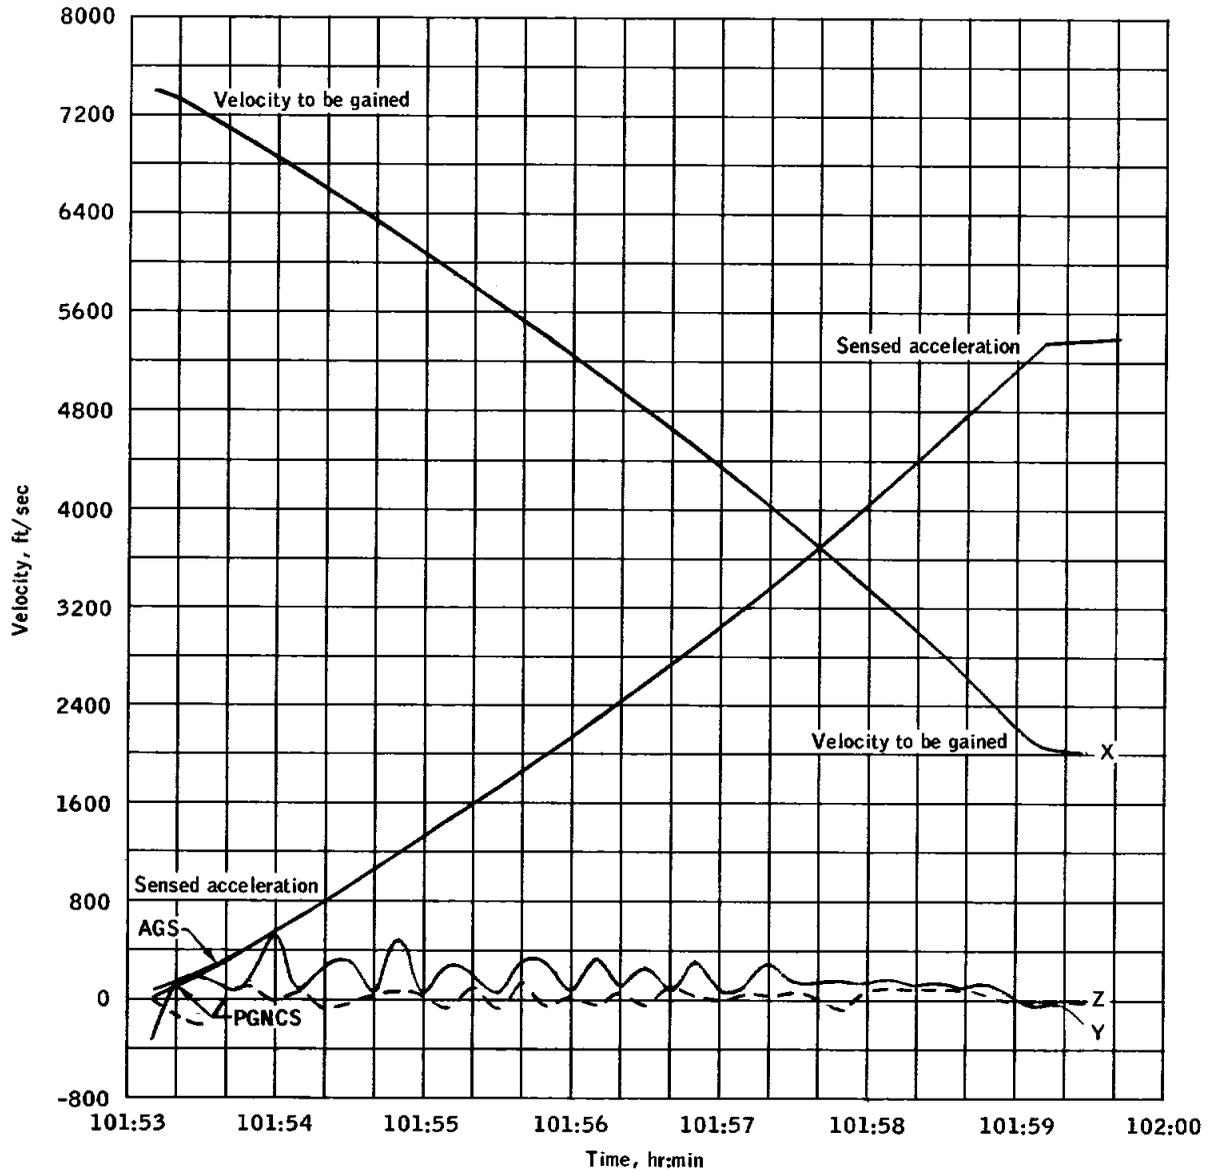
Figure 9.6-8.- Velocities during ascent engine firing to depletion.

The large velocity-to-be-gained remaining at the end of the ascent engine firing to depletion (fig. 9.6-8) is a result of the propellant depletion cutoff. The loss of acceleration was sensed by the velocity monitor routine in the computer. The routine activates when the velocity change accumulated in each of two consecutive 2-second periods is less than 10.1 ft/sec. The computer reacted properly, by recycling back to the 5-seconds-before-ignition point in the program sequence, and turned on the plus X translation after propellant depletion.

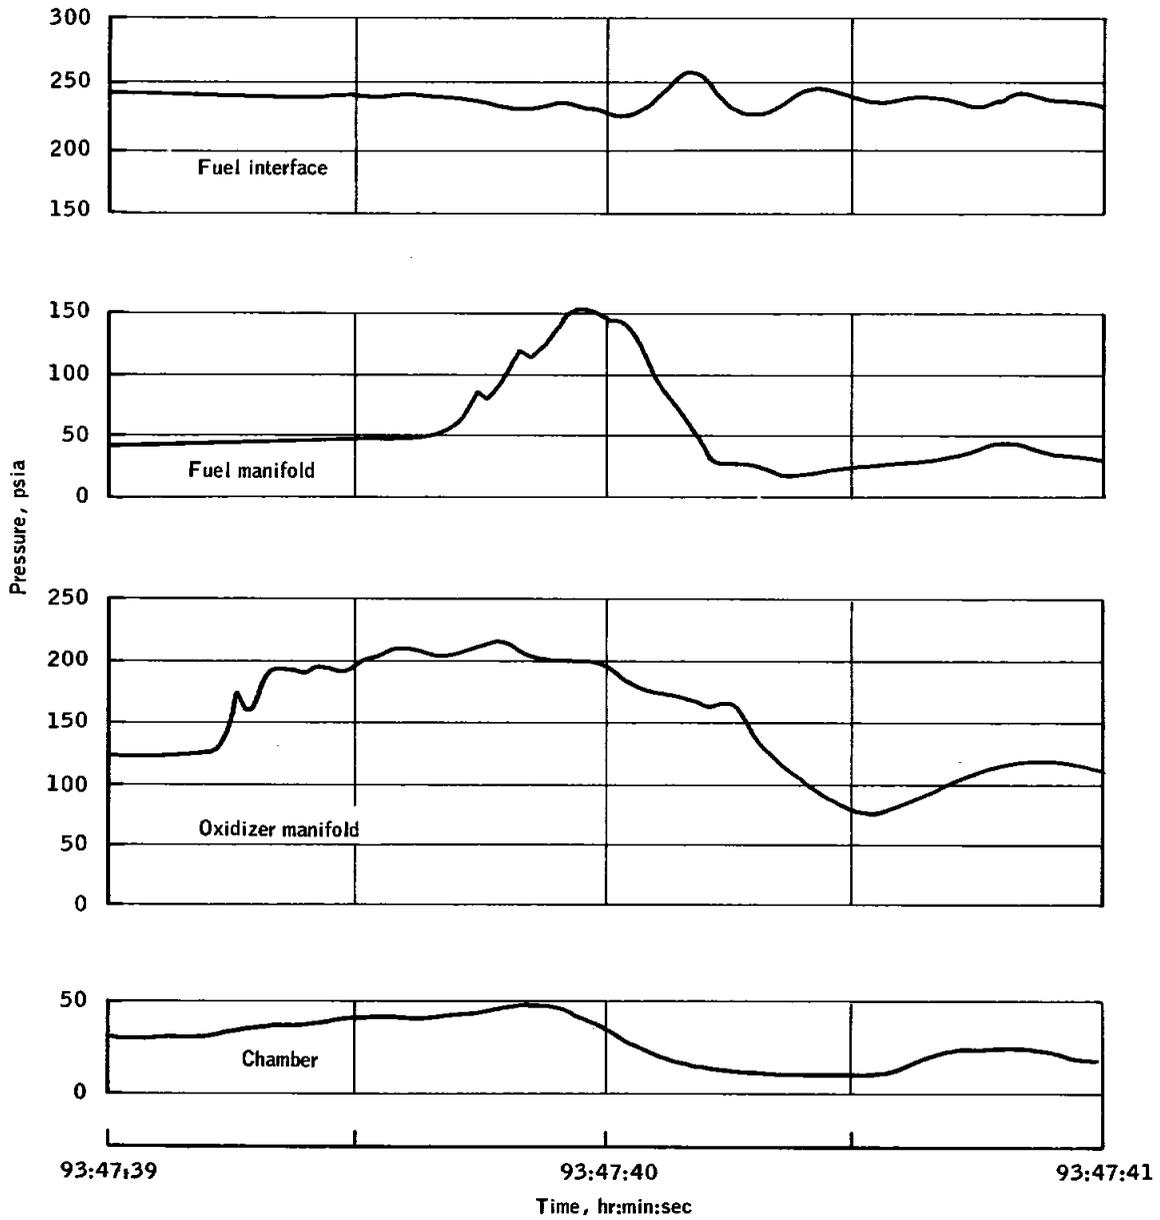
Figure 9.8-2.- Descent propulsion system pressures during second firing (phasing maneuver).

constant until the roughness ceased. This roughness is typical of that experienced with helium ingestion into the combustion chamber. The roughness lasted approximately 2.5 seconds, (see figure 9.8-2) and the remaining portion of the second firing and all of the third firing appeared nominal. See section 17 for further discussion.

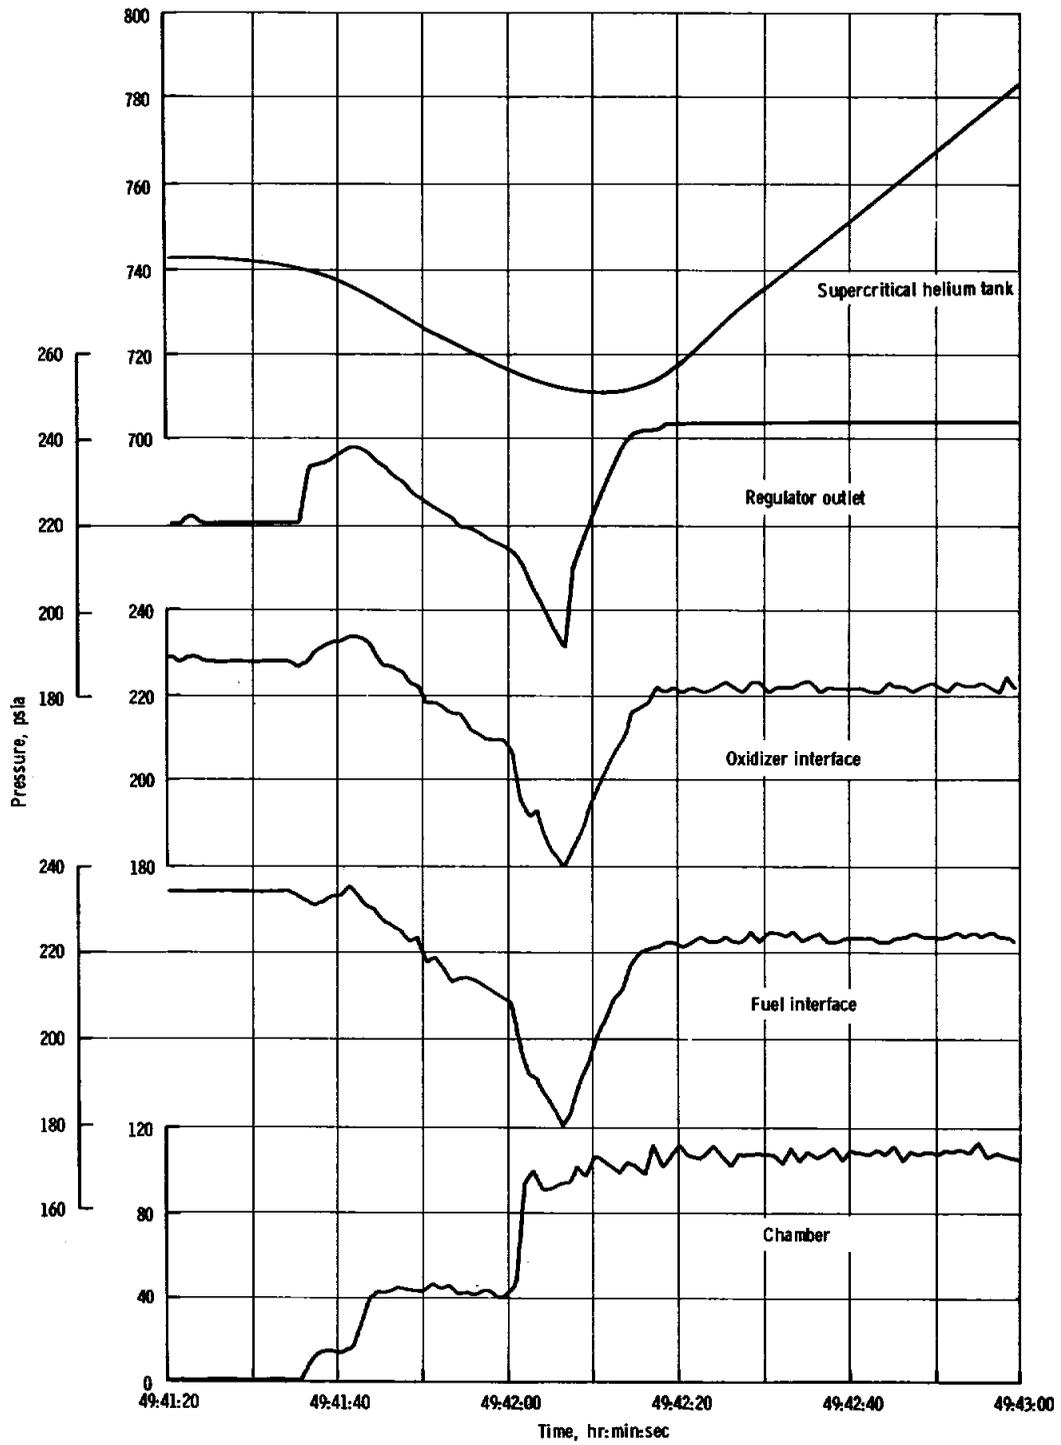
Figure 9.8-3. - Descent propulsion system pressures during start of first firing.

During the first lunar module manning, the helium system pressure was about 743 psia. During the first 33 seconds after engine ignition, the helium bottle pressure decreased to approximately 711 psia (see figure 9.8-3). At the same time, a decrease from 235 to 188 psia in the regulator-outlet manifold pressure was observed. If the system had operated correctly, sufficient helium would have passed through the regulator to maintain a constant regulator-outlet manifold pressure of about 247 psia and the heat transfer through the internal heat exchanger should have increased the pressure in the supercritical helium bottle. The data indicate that the internal heat exchanger was plugged during the initial portion of the firing. See section 17 for further discussion.

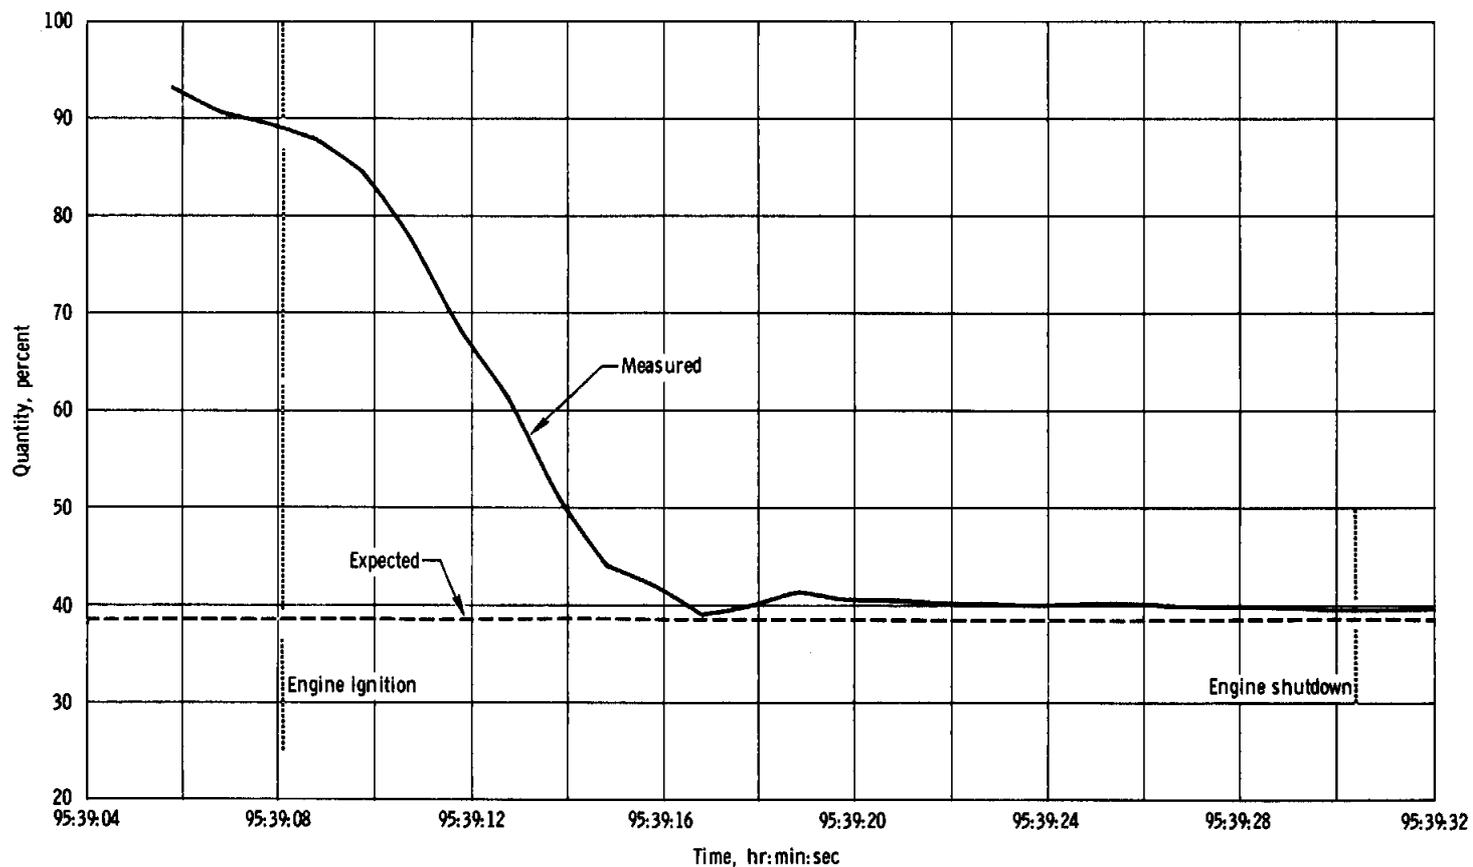
Figure 9.8-4. - Typical descent propulsion quantity gaging system operation (oxidizer tank 1).

service propulsion system gaging system which also used capacitive measuring devices. In general, the displayed quantities were greater than the actual tank quantities (see figure 9.8-4). As the firings continued, the gages tended to stabilize toward correct values. The firing time for the last two maneuvers was too short for the gaging system to completely stabilize.

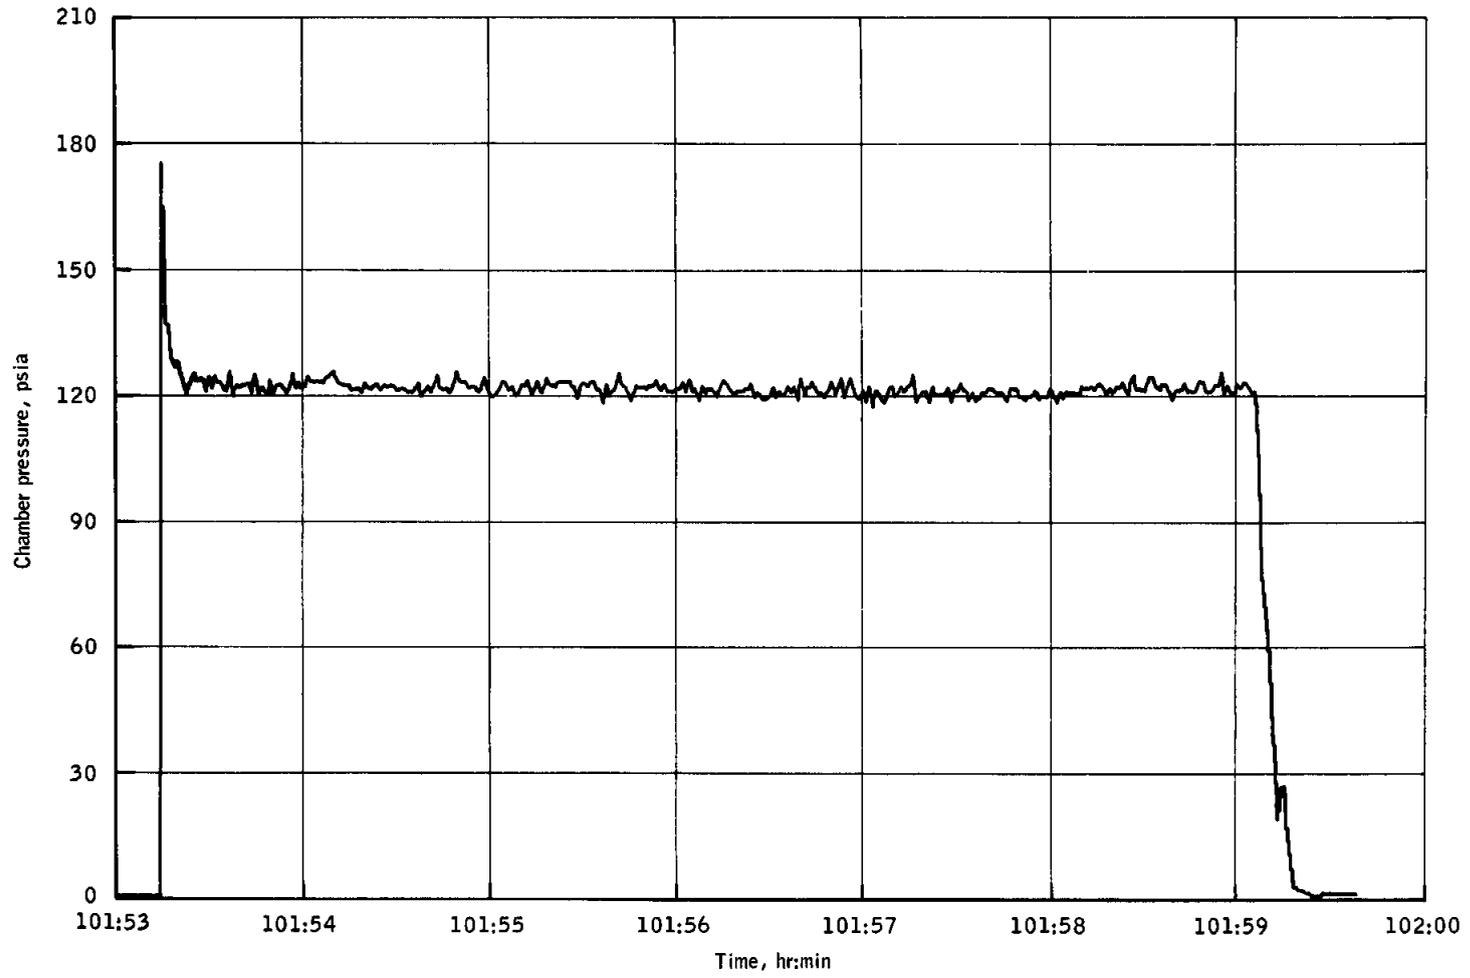
Figure 9.9-2.- Ascent engine chamber pressure during firing to depletion.

The transient characteristics that the engine demonstrated during an oxidizer depletion shutdown mode are shown in figure 9.9-2. This figure provides a comparison of flight data with ground test data. The data indicate that the characteristics of the oxidizer depletion during flight compared favorably with the ground test.

Table 9.9-III compares the actual and predicted ascent propulsion system performance during the firing to depletion. The measured flight data compared closely with the predicted values for the actual regulator pressure conditions. Figure 9.9-2 is a time history of the chamber pressure during the firing to depletion.

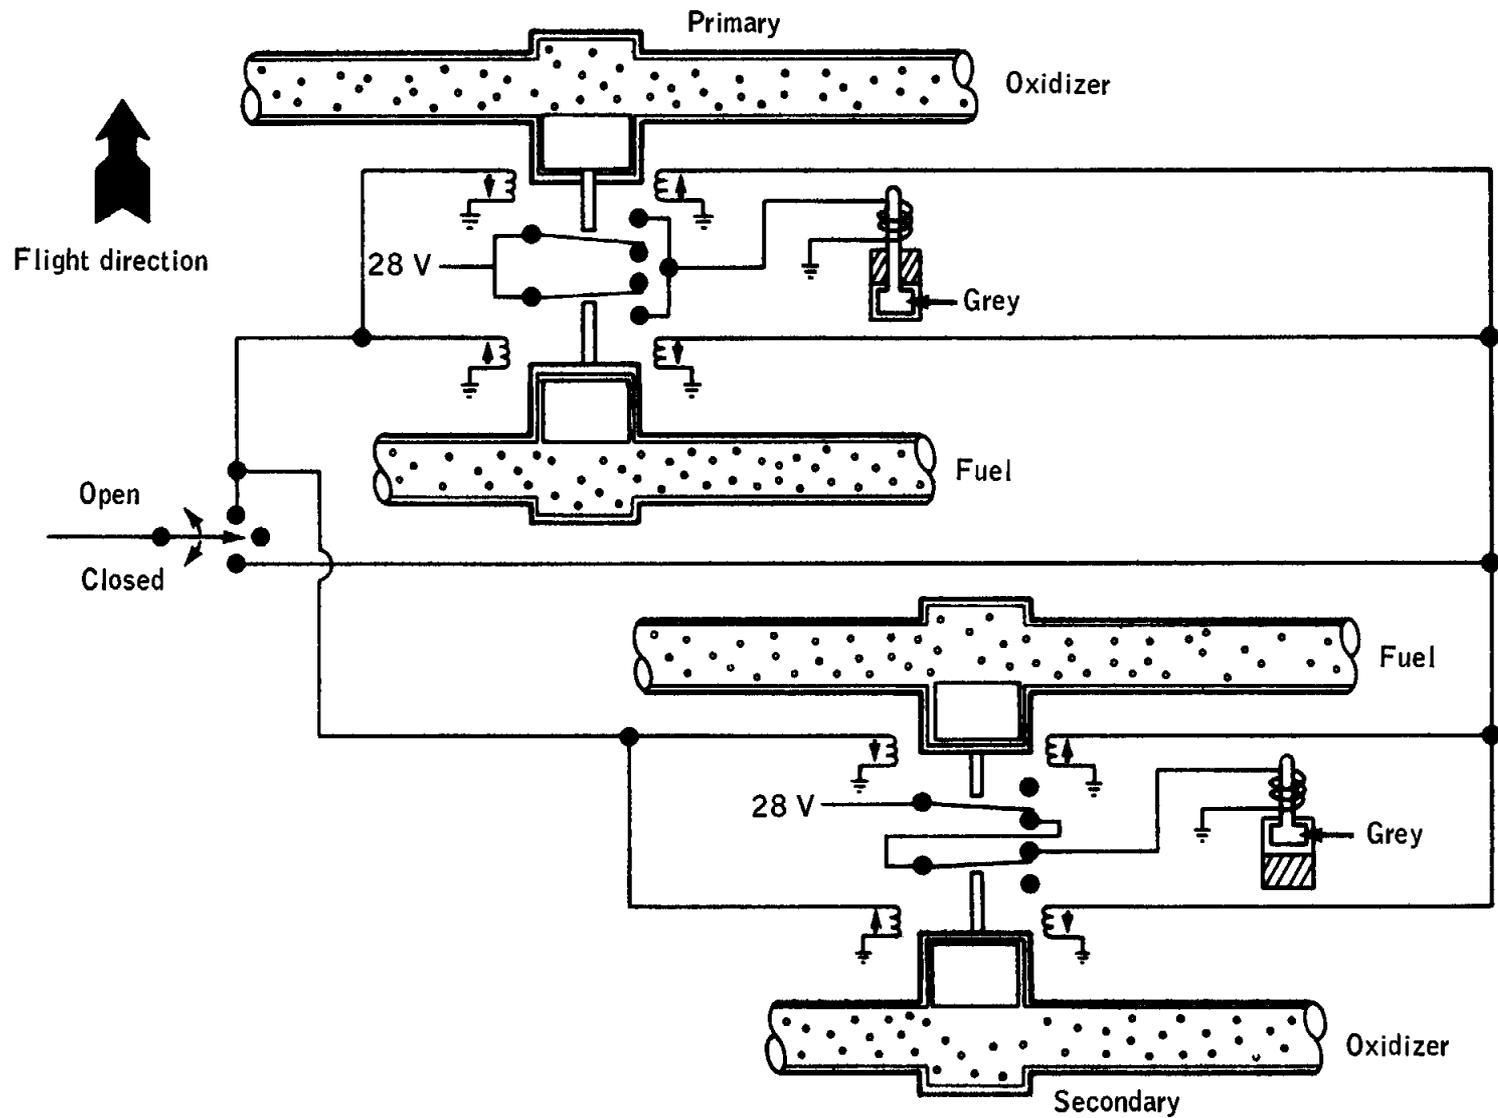
Figure 17-1.- Reaction control isolation valve.

The isolation valve magnetically latches open and is spring-loaded to the closed position. The valves are controlled by momentary switches, located on panel 2, which are spring-loaded to center-off. The four isolation valves in each quad are controlled by one switch (fig. 17-1). The quad C and D switches are adjacent to each other, and normally all four primary and secondary valves are opened or closed simultaneously. The closed indication in quad D for the secondary valves only required that either one or both of the secondary valves be closed, but neither of the primary valves. Tests have demonstrated that it is possible to strike the switch momentarily so that only one of the four valves is closed, but this occurrence has only been demonstrated once in two hundred attempts. Each switch is guarded by a wicket which extends slightly beyond the switch to minimize inadvertent actuation; however, since the switch is spring-loaded to center, inadvertent actuation could go undetected.

Propellant usage data (fig. 17-2) showed that all four quad C valves were closed and that quad D was performing normally before the crew reopened the propellant isolation valves. Propellant may be supplied from either the primary or secondary tanks, and only the valve indicator for the secondary tank was in the "barber pole" position for quad D. Closure of only one of the secondary valves is sufficient to cause the indication (fig. 17-1).
